Subject: Raceway Qualification Test with Pre-Damaged THU2 BTF-0065

**Raceway Qualification Test with Pre-Damaged THU2 BTF-0065**

Key words: Truck Hub Unit, Raceway Qualification Test, Damage

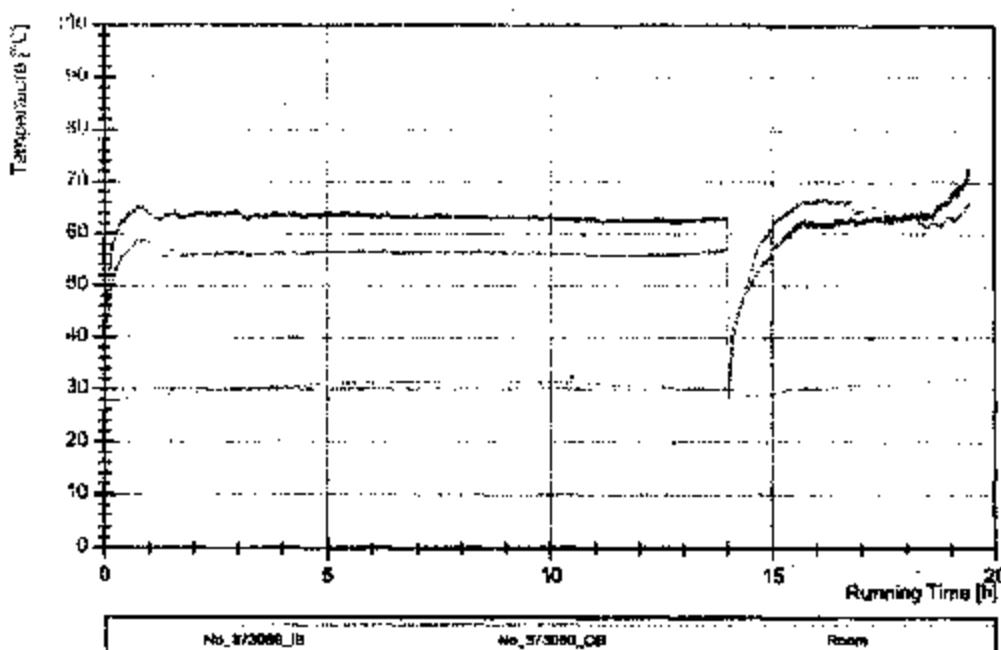
After the addition of the aforementioned 5 grams of water, the test bearing completed 14 hours of operation and the following standstill period. Upon restart of the operation, it was noticed that the bearing temperature increased steadily, indicating a bearing damage (see picture 3).

Picture 3: Temperature recording indicating bearing damage after standstill period
